Tectonically-Controlled Disaster Risk Assessment Study Along Palu-Koro Fault In Donggala Regency, Central Sulawesi: Record From 2018 Earthquake Effect

Sumarlin Usman^{1}, Asri Jaya², Adi Maulana^{2,3}*

One of the major tectonic manifestation in Sulawesi Island is the Palu-Koro fault which extends north-northwest to south-eastwards in the centre of the island. The presence of the Palu-Koro Fault has responsible for the series of natural disasters occurred in Central part of Sulawesi and its surrounding which include earthquake, tsunami, liquefaction and subsidence. The need for further tectonic studies and geological structure mapping surrounding the fault is very important for disaster risk reduction strategy including mitigation effort to reduce casualties affected by future disasters. The study was conducted along Palu-Koro Fault Zone in Donggala Regency, Central Sulawesi. This study aims to assess the disaster risk including vulnerability, threat and capacity that generated by tectonically-controlled process along Palu-Koro Fault in Donggala Regency due to 2018 earthquake. The methodology used includes disaster risk reduction assessment approach, field geological structure obs

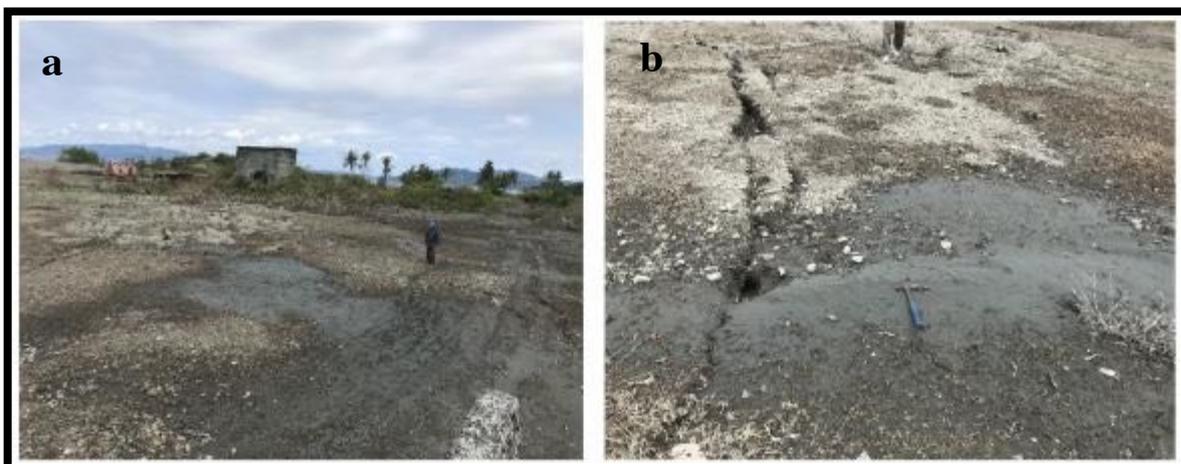
Figure 4. Occurrences of liquefaction in Dampal area as shown by intensive fracture of alluvial rock, a) soil subsidence, and b) surface water pushing the material to appear on the surface in the form of a sand boil

(1) Alluvial soils (sand, silt and clay) that are not well consolidated are encountered in many valleys and slopes, such as on the coast along the West coast of Donggala Regency; (2) Earthquake intensity (5-8 Mw) and high vibration intensity (MMI V-IX), if there is strong vibration and shaking in this range, it will easily trigger soil slurry; (3) high groundwater conditions (types of surface water and shallow groundwater types and water saturation in coastal areas); (4) Some places have shown vertical displacement and soil structure damage, crack and fractured, such as the coast of Lero and Sirenja; (5) The emergence of sand boils in several locations after the 2018 Palu earthquake, such as in the Dampal area (Fig. 4).
